PIANC WORKSHOP

'MITRE GATE DESIGN and OPERATION'

*In the framework of
the PIANC InCom Report n°154*

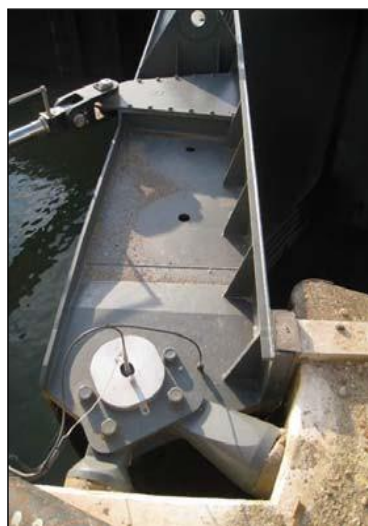
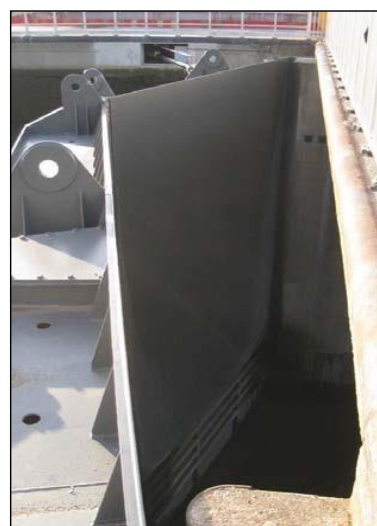
The Maasbracht Locks (Sluizencomplex Maasbracht) located on the Juliana Canal in the Netherlands. A variety of interesting issues will be discussed including hinge design using FRP, anchorage failure, fatigue design of welded connections, and contact blocks using FRP.
